# Draft Maryland Condition Index (MDCI)

## Summary of Needs Weighting

Workgroup on the  
Assessment & Funding  
of School Facilities

9/25/19

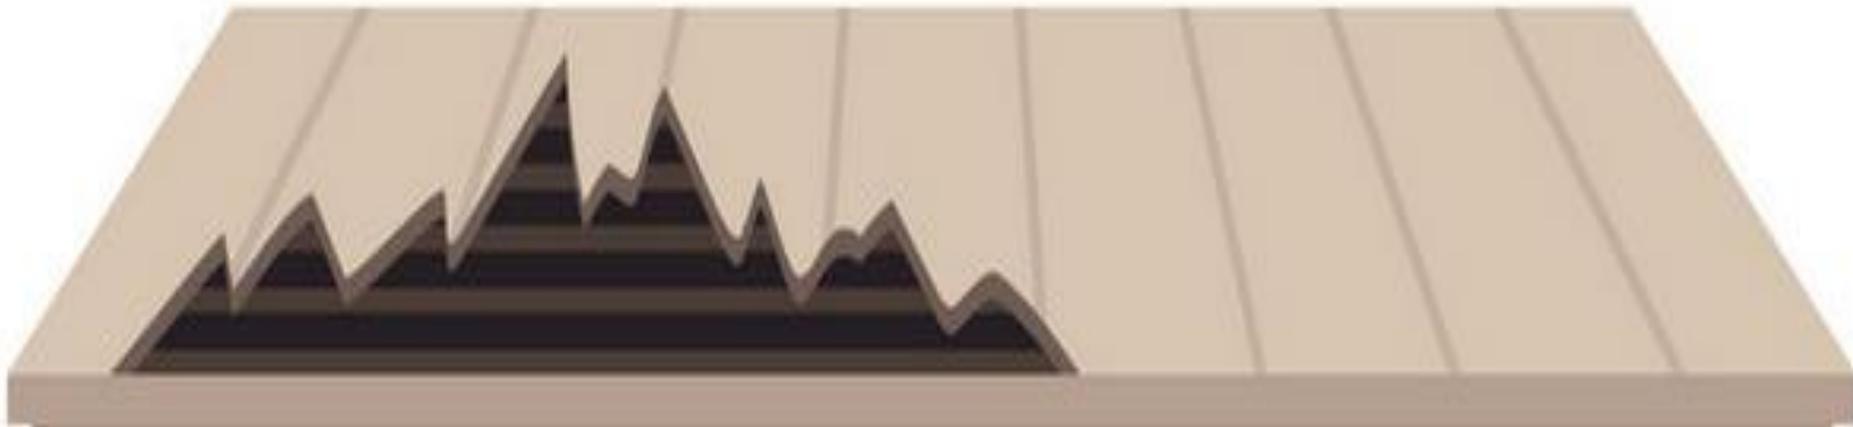
# Component 1

*The roof costs **\$200 to replace**, and is **50% degraded**.*

*Therefore, its **repair value is \$100**.*

*The roof is within its expected life cycle, so it is assigned to **Category 9**, with a **weight of .25**.*

1) *Our roof's repair value is **weighted by .25.**  
.25 weight x \$100 repair value = \$25*

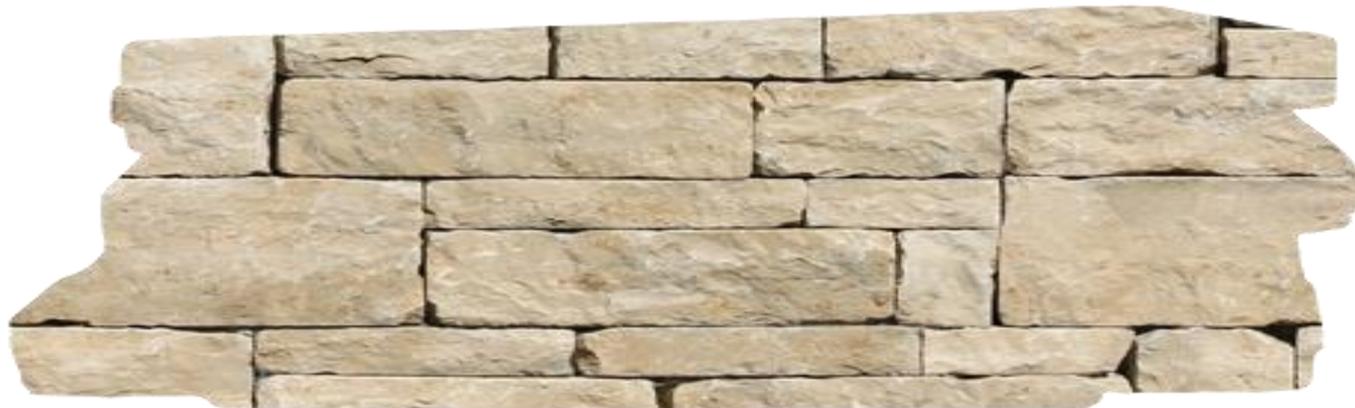
## Component 2

*The exterior walls cost **\$100 to replace**, and are **80% degraded**.*

*Therefore, its **repair value is \$80**.*

*The walls' original expected life of 60 years has been reduced, because there are indicators that additional failure is imminent.*

*Therefore, it is assigned to **Category 3**, mitigate additional damage, with a **weight of 2**.*

2) *Our walls' repair value is **weighted by 1.5.**  
1.5 weight x \$80 repair value = \$120*
