# **State of Maryland Interagency Commission on School Construction**

## **Maintenance of Maryland's Public School Buildings Fiscal Year 2023 Annual Report**

# FY 2023 Annual Report: Maintenance of Maryland's Public School Buildings

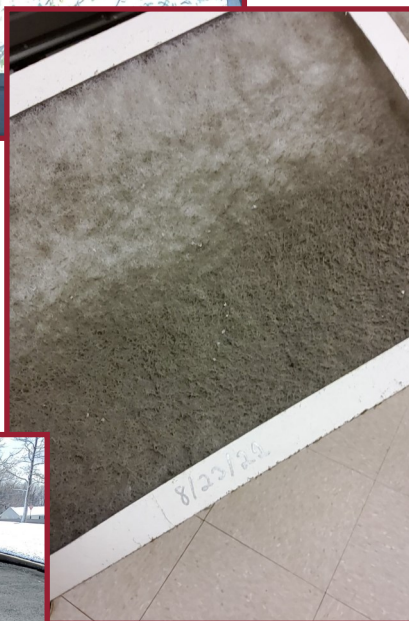
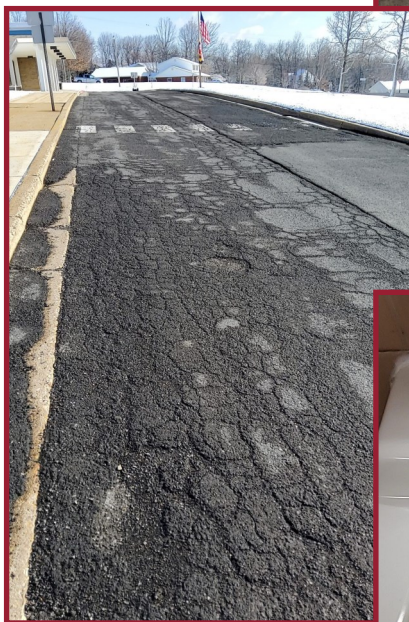
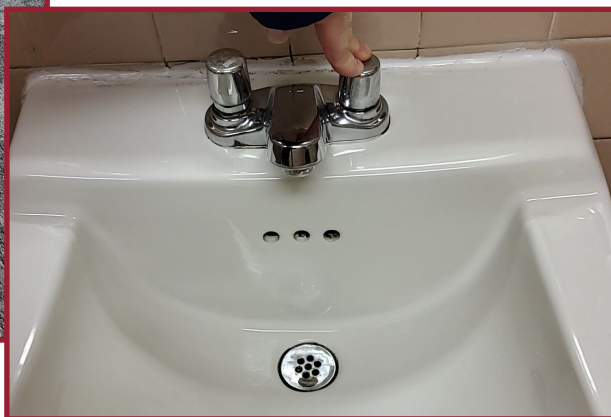
Roadways, parking lots, and walkways were not identified in the PM schedules for the assessed facilities.

Cracked and deteriorated roadways and parking lots were observed at two facilities as well as trip hazards due to uneven walkway surfaces. Ponding water was noted in the parking lot at one facility.

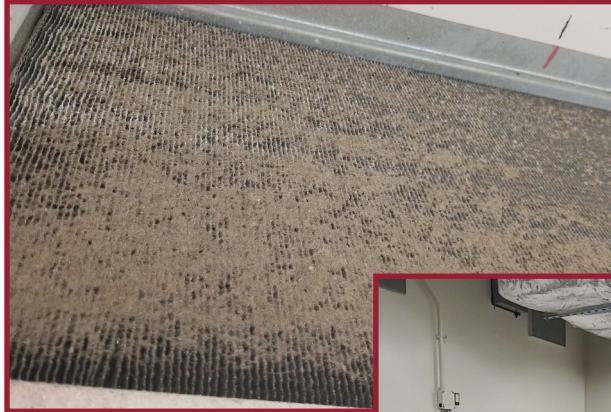
The kitchen walk-in equipment was not identified in the PM schedules for the assessed facilities. This equipment was noted with dirty coils at four facilities. Three facilities received a Not Adequate rating in the HVAC category.

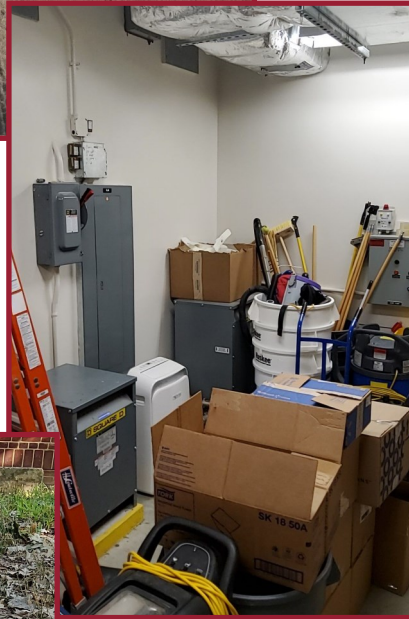
Improper or unsafe storage practices were identified at 10 facilities, which in some instances were blocking egress routes or equipment. Five facilities received a Not Adequate rating in the Interior Cleanliness & Appearance (incl. of Equip. Rooms) category. The custodial scope of work identifies area-specific custodial tasks and frequencies but these activities are not tracked using the CMMS.

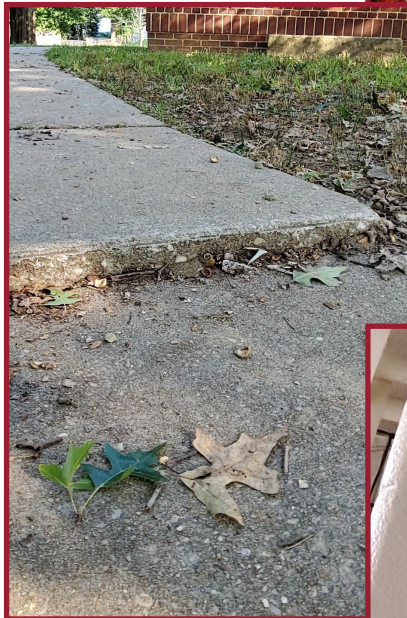
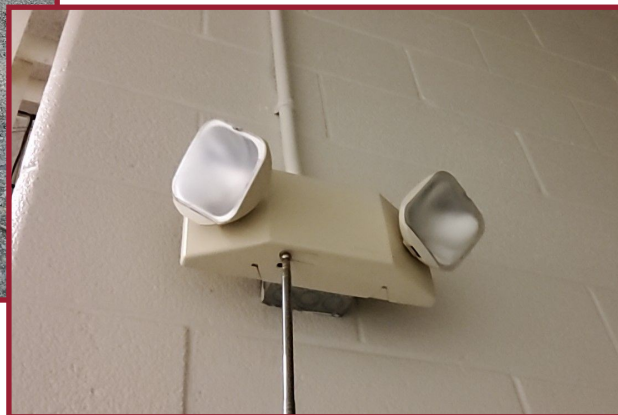
Roadways, parking lots, and walkways were not identified in the PM schedules for 13 of the assessed facilities. Uneven walkway surfaces were noted at five facilities as potential trip hazards. Five facilities were observed with cracked walkways.

Potential safety issues were noted at seven facilities due to inoperable emergency lights, emergency exit signs, and/or eyewash stations.

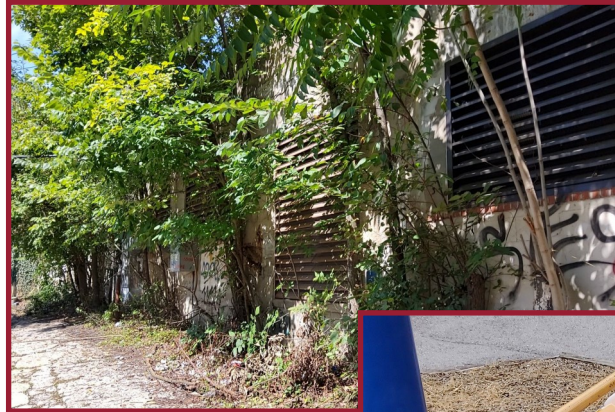
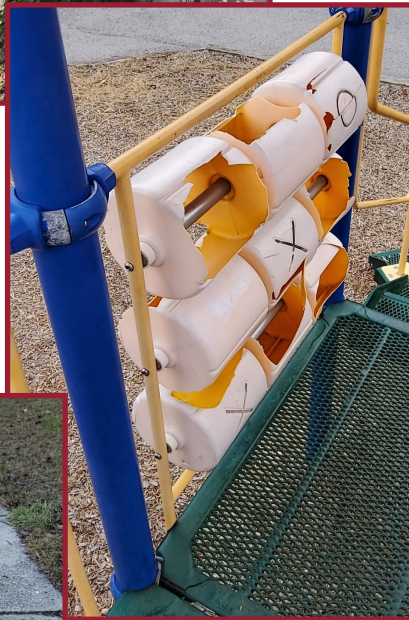
Overgrown vegetation was observed at 15 facilities; at 11 of those facilities, the vegetation was in contact with or growing against building surfaces.

Playground and play equipment inspections are included in the LEA's grounds assessment; damaged playgrounds and/or play equipment were identified at 10 facilities. No playground inspection reports were provided in the required pre-assessment documentation for the 13 applicable facilities.

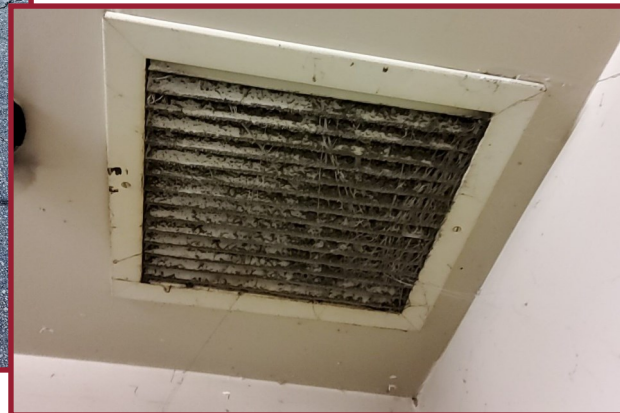
Various cleaning activities are identified in the Custodial Operations document, including weekly high dusting and monthly dusting of the ceiling areas and light fixtures; dirty ceilings, light lenses, and/or HVAC vent covers were noted at 13 facilities.

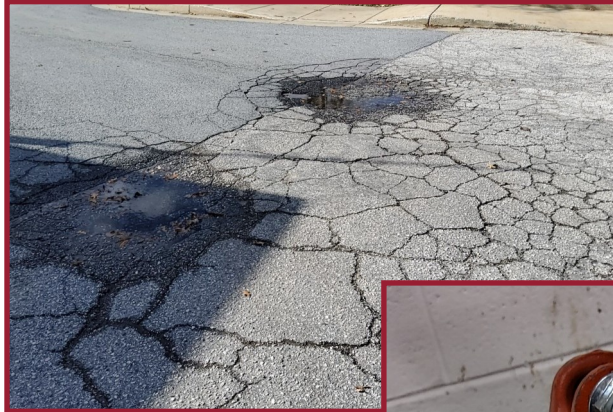
Cracking and/or deterioration, from minor to severe, was noted in the roadways and/or parking lots at 16 facilities. Other than a general site care PM which includes checking and cleaning curbs, gutters, roadways, parking lots, and walkways are not identified in the PM schedules for the assessed facilities.

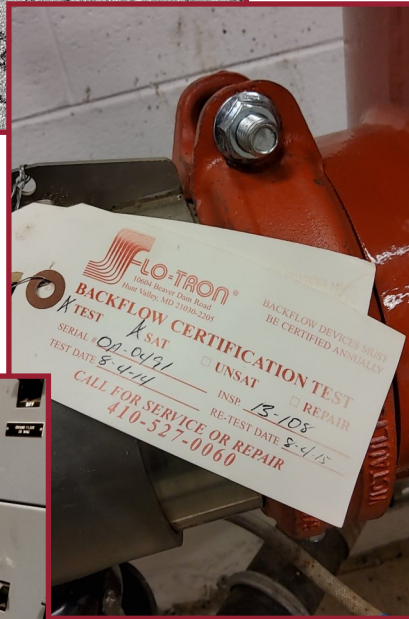
The backflow preventers in 13 facilities had either expired inspection tags or were missing tags. One facility appeared to have a backflow preventer with an inspection tag, but it was inaccessible and the tag's date could not be verified. Backflow preventers, plumbing fixtures, and related equipment were not identified in the PM schedules for the assessed facilities. Of the 17 facilities assessed, 16 received a Not Adequate rating in the Plumbing Fixtures and Equipment category.

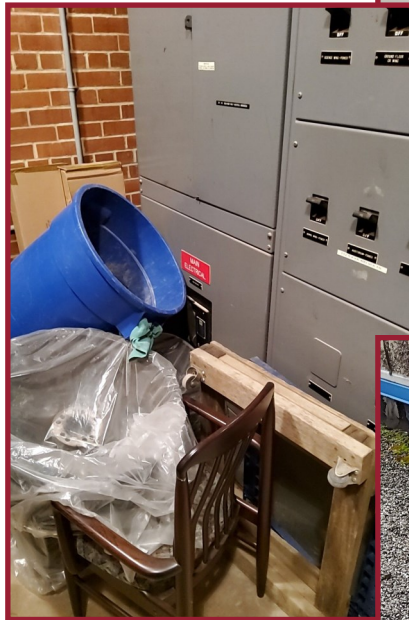
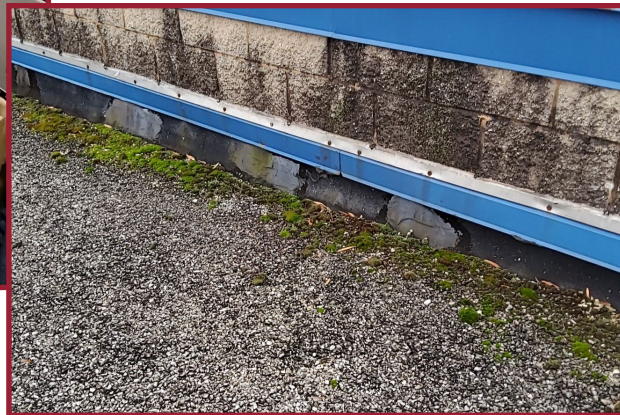
Unsafe storage practices, such as cluttered storage rooms, items stored too close to the ceiling, and items blocking egress or access to equipment, were observed at 15 facilities. Evidence of pest activity was noted in food prep and/or eating areas at six facilities. Eight facilities received a Not Adequate rating in the Interior Cleanliness & Appearance (incl. of Equip. Rooms) category.

Vegetative growth was observed on the roofs at eight facilities. Eight facilities received a Not Adequate rating and one facility earned a Poor rating in the Roofs, Flashing, and Gravel Stops category.

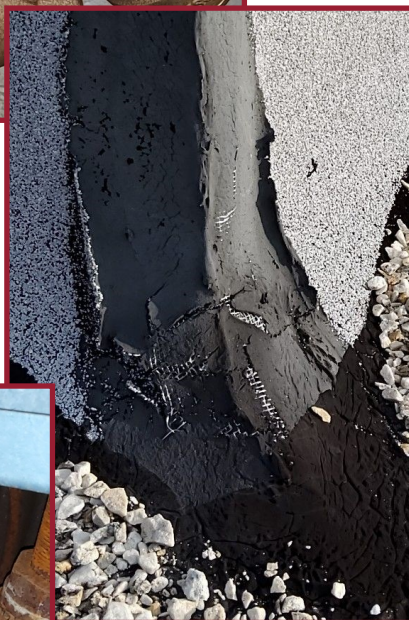
Two facilities were observed with cracked and deteriorated lap seam sealants on their roofs. One facility's roof inspection report indicated two sections of the roof are in poor condition, leak, and need replacing; at the time of the MEA, there were no open work orders for the roof, and CCPS did not indicate any plans for a roof replacement project.

One facility was observed with corrosion on two boilers, a water heater, and two pumps, some of which was severe. Another facility was noted with minor corrosion on three pumps and a water heater and boiler locked out of service with no associated work orders identified in the CMMS.

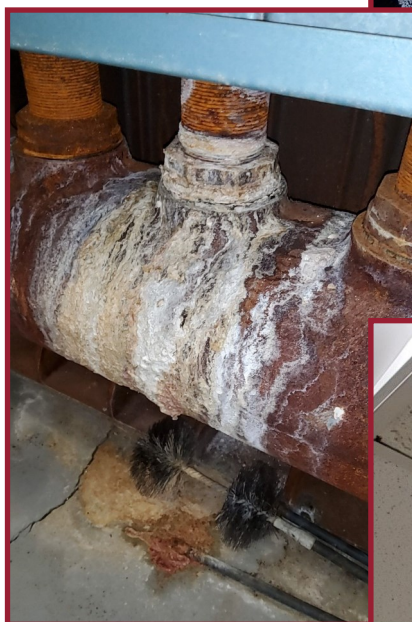
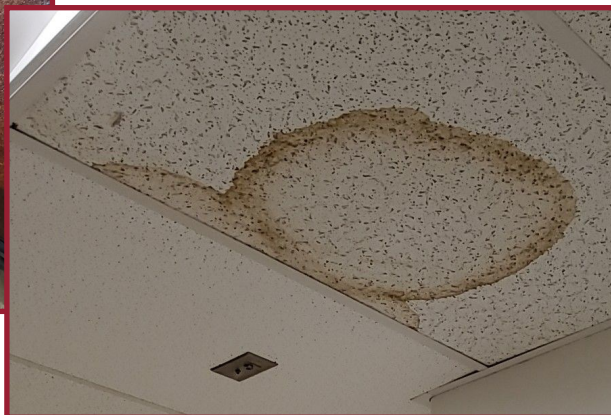
Stained and damaged ceiling tiles were observed at two facilities. Ceiling maintenance was not identified in the PM schedules for the assessed facilities. One facility received a Not Adequate rating in the Ceilings category.

- Regularly scheduled ceiling inspections should be created and tracked using the CMMS to identify any ceiling tiles missing, stained, or damaged. Corrective work orders should be created in the CMMS immediately following any inspection where deficiencies or issues are noted. Stained ceiling tiles should be replaced once the cause is identified and repaired.

- Corrosion on equipment should be evaluated and addressed before additional damage or operational damage occurs.
- Implementing quality control procedures is recommended to ensure PM work orders are being completed effectively and the actions taken to complete the work are recorded accurately.

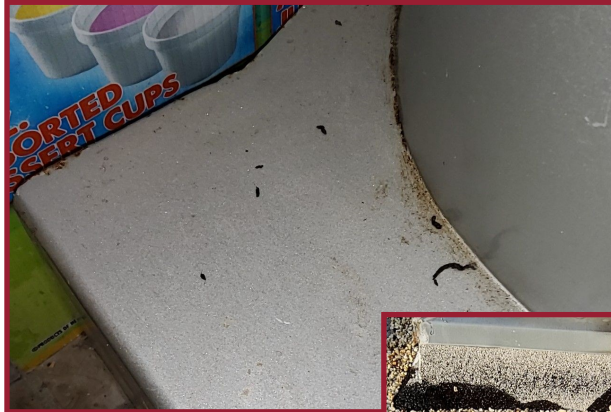
All three facilities received a Not Adequate rating in the Interior Cleanliness & Appearance (incl. of Equip. Rooms) category, and all three facilities were observed with rodent droppings in kitchen areas. Pest management activities

are identified in the LEA's integrated pest management policy, but were not tracked using the CMMS and did not appear in the PM work order history for any of the assessed facilities.

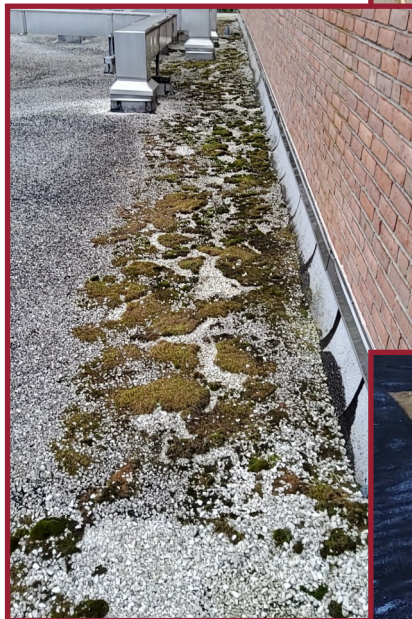
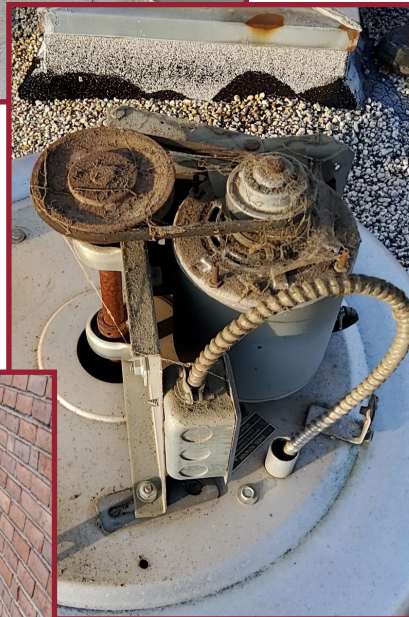
Annual and monthly roof inspections are identified in the CMP, but were not tracked using the CMMS and did not appear in the PM work order history for any of the assessed facilities. Vegetative growth was identified in multiple areas on the roofs at two facilities, which was also identified as a weakness for CCPS in FY22.

Routine operations checks and standard maintenance for various HVAC equipment are identified in the CMP, but were not tracked using the CMMS and did not appear in the PM work order history for any of the assessed facilities. Inoperable exhaust fans were observed at two facilities. Various HVAC equipment was noted with dirty filters at all three facilities. Two facilities received a Not Adequate rating in the HVAC category.

- PM activities for roofs and HVAC equipment should be added to each facility's PM schedule to help extend the useful life of the existing surfaces and assets, prevent hazardous conditions, and avoid premature capital replacement projects. Corrective work orders should be created in the CMMS immediately following any inspection where deficiencies or issues are noted.

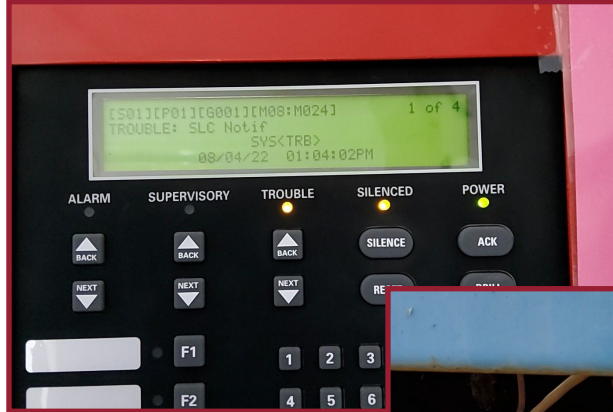
No fire alarm inspection reports were provided in the required pre-assessment documentation for any facility, and three facilities had their fire alarm panel in trouble status during the MEA.

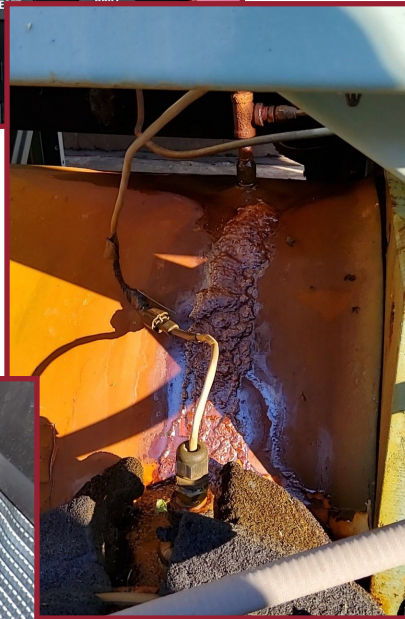
Evidence of extensive corrosion and potentially damaging water quality in the chilled water loop was observed at one facility. Observations included rust and slime surrounding an active leak at the chiller and a concerning amount of rust flakes in water regularly flushed from a port which indicate that treatment of the hydronic water loops is not taking place or is ineffective. No evidence of a water treatment program was identified for the HVAC equipment at any of the assessed facilities.

- It is recommended that a water treatment and testing program for all closed-loop hydronic systems be developed and implemented in order to achieve the expected life span of piping, pumps, coils, and associated components, and to avoid interruption of educational delivery due to cooling and heating breakdowns. An internal pipe inspection should be completed to evaluate the damage caused by the observed corrosion in the assessed facilities, and an action plan created to remediate the issues. A water treatment plan should be implemented and routinely maintained by a qualified professional. The CMMS should be used to track hydronic system water treatment activities.

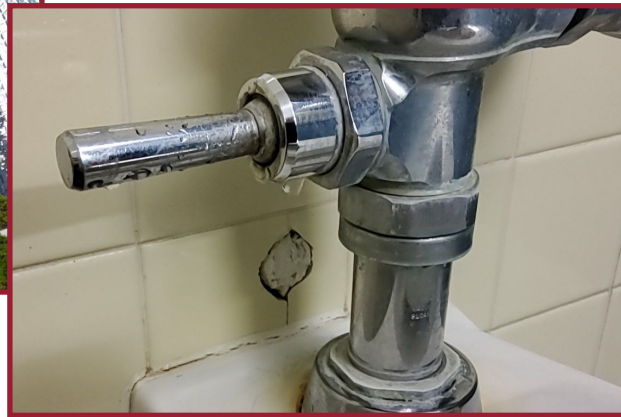
Annual roof inspections are identified in the CMP, but were not tracked using the CMMS and did not appear in the PM work order history for any of the assessed facilities. Vegetative growth and/or debris was observed on the roofs at four facilities. Sealants were noted as peeling, failing, and/or deteriorating at four facilities.

The backflow preventers at three facilities were noted with either expired or missing inspection tags. All five facilities were observed with leaking plumbing fixtures.

- Corrective work orders should be created in the CMMS immediately following any inspection where deficiencies or issues are noted and identified as inspection deficiencies. This will help identify trends and common issues in order to better proactively maintain areas.

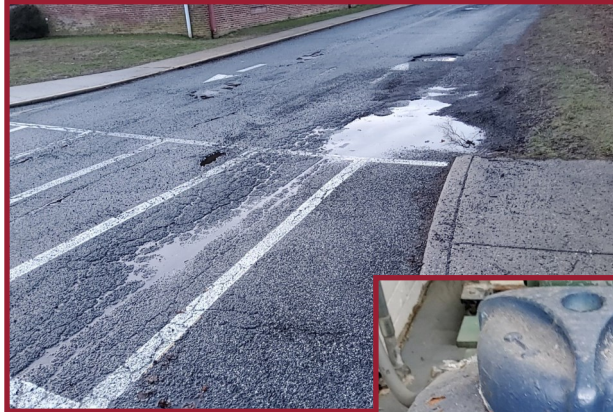
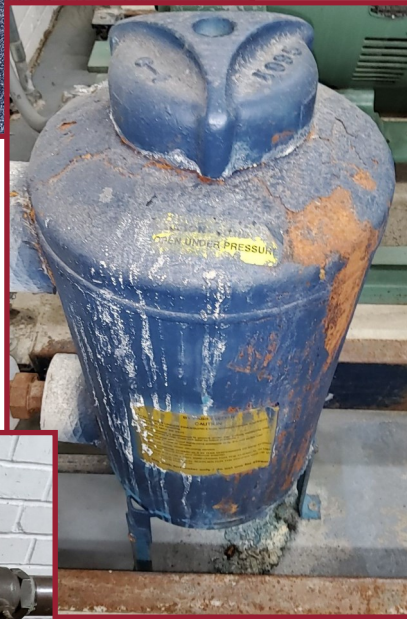
Roadways, parking lots, and walkways were not identified in the PM schedules for the assessed facilities. At two facilities, the parking lots were observed with cracks or deterioration. The walkways were noted with deterioration at two facilities.

Annual boiler maintenance was identified in the PM schedule for one facility but no PM work orders were identified in the PM work order history and the pumps and water heater were not identified in the PM schedule. The boilers and water heaters were not identified in the PM schedules for the other three facilities. While one facility had no issues or concerns with the boilers, water heater, or hot water distribution, the other three facilities had notable concerns; one facility was observed with a leak, one facility was missing a DLLR certificate, and one facility was observed with corrosion on multiple pumps and a bypass feeder.

- Roadways and parking lots should be added to the PM schedule. Consider applying sealants to asphalt parking lots and roadways to slow deterioration until such assets can be resurfaced.

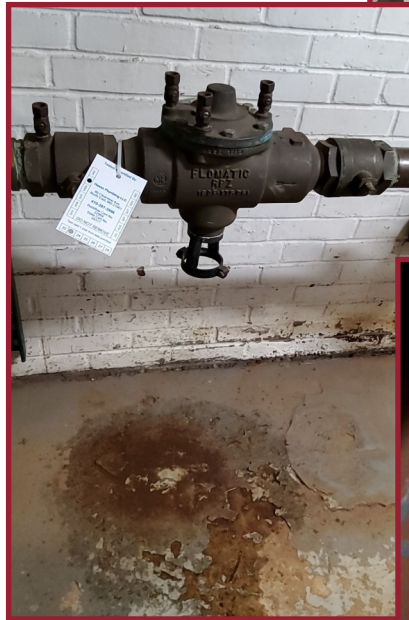
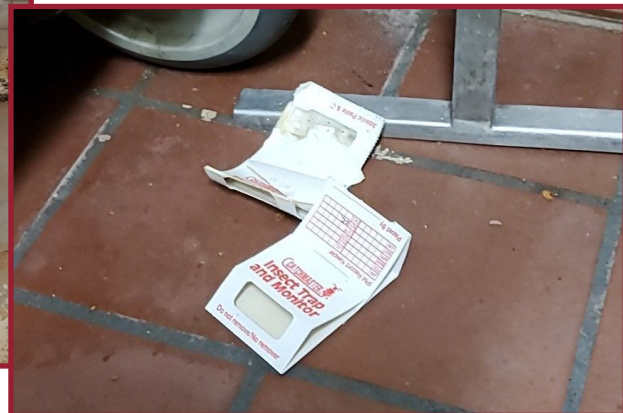
Some essential assets were not identified in the PM schedules for the assessed facilities, such as backflow preventers, HVAC units, interior lighting, and some DLLR-regulated equipment. Some assets were identified in the PM schedule but not in the PM work order history or were identified in the PM work order history but not in the PM schedule.

Pest management appeared to be inconsistent. Some facilities had dated sticky traps, some did not. One facility was noted as not using the pest activity log. Three facilities had pest management PM work orders, one did not. Pest activity was identified at three facilities.

- Expand the asset list for each facility to encompass all essential and non-essential assets to store and manage asset-specific data (such as asset name, purchase date, purchase price, expected life span, model number, serial number, asset tag number or unique identification, type of asset, location, and any other relevant details), and use the CMMS to track the maintenance and repair history as well as performance of each asset over time.

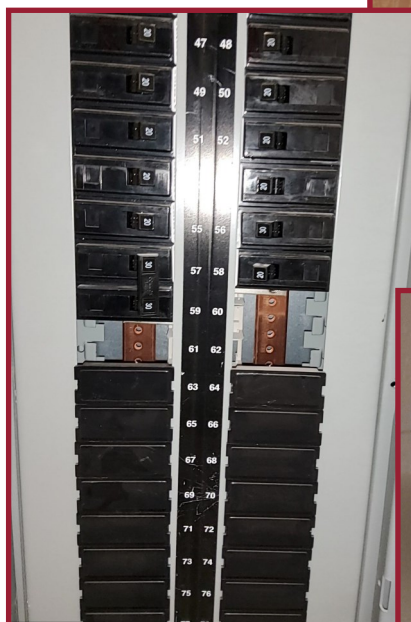
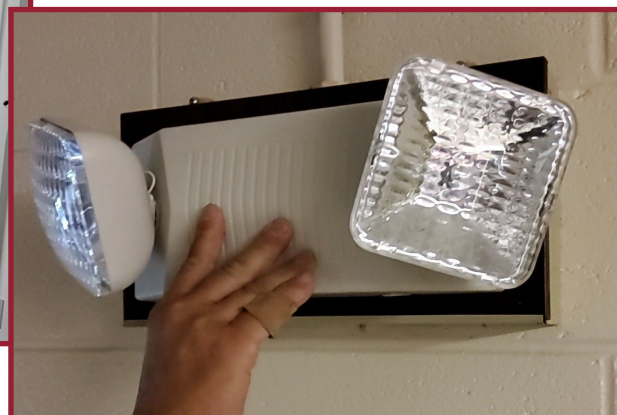
Three facilities were noted with breaker blanks missing from electrical panels. The generator appeared to be leaking oil at two facilities, and was not connected to the building's electrical system at another facility. Electrical equipment and generators were not identified in the PM schedules for the assessed facilities.

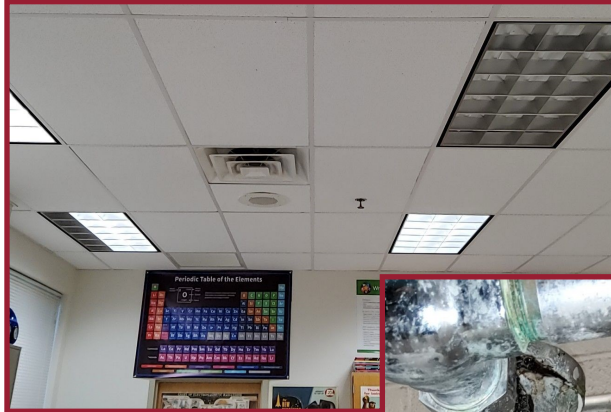
Many essential assets were not identified in the PM work order histories for the assessed facilities, such as switchgear, roofs, generators, backflow preventers, interior lighting, playgrounds, water heaters, conveyances, and pest management activities.

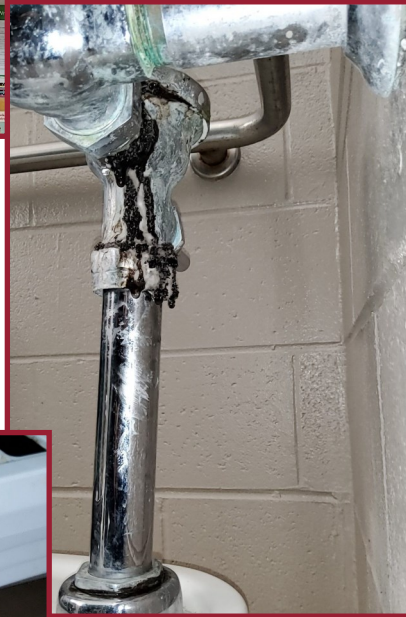
One facility was noted with having a completed PM work order for restroom fixtures and was observed with only a minor leak at one toilet fixture. The other two assessed facilities were identified with multiple corroded and leaking toilet fixtures; an open restroom fixtures PM work order was identified in the CMMS history for one facility but no completed PM work orders, and there were no plumbing fixtures or equipment PM work orders identified in the CMMS history or PM schedule for the other facility.

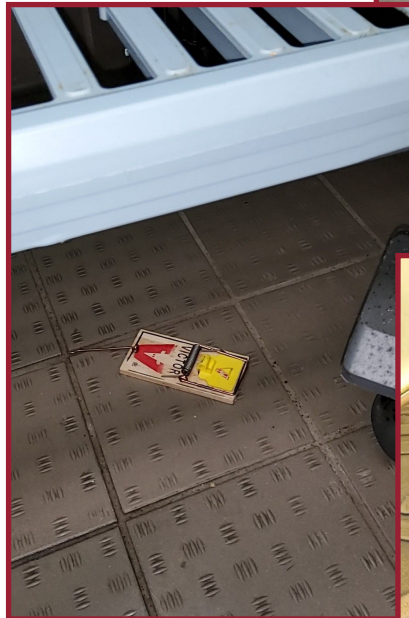
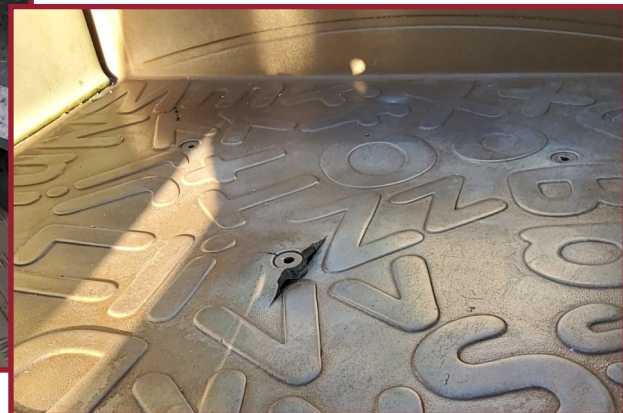
Some of the sticky pest traps were not dated to track pest activity and two facilities were observed with pests in traps in food areas and snap traps missing bait. Pest management PM activities were not tracked using the CMMS for any of the assessed facilities.

Potential safety issues were observed on the playgrounds at the two facilities with these assets. Scheduled playground inspections are identified in the CMP, but were not tracked using the CMMS and did not appear in the PM history for either of the applicable facilities.

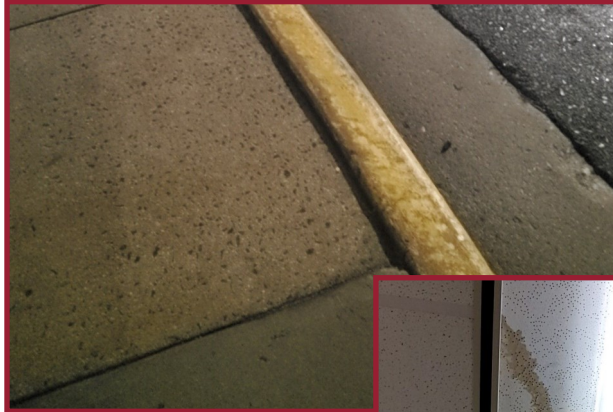
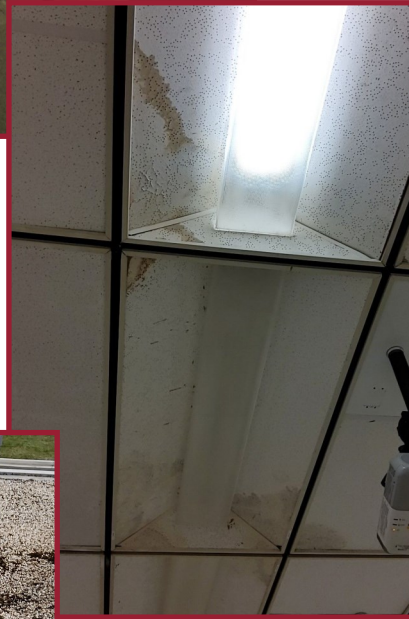
Roadways, parking lots, and walkways were not identified in the PM schedules for the assessed facilities.

Four facilities were noted with minor trip hazards due to uneven surfaces between the curbs and walkways.

Light to widespread cracking was observed in the roads and/or parking lots at six facilities.

- Roadways and parking lots should be added to the PM schedule. Consider applying sealants to asphalt parking lots and roadways to slow deterioration until such assets can be resurfaced.

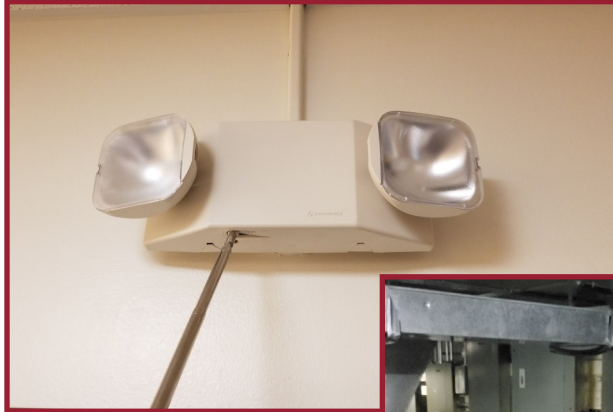
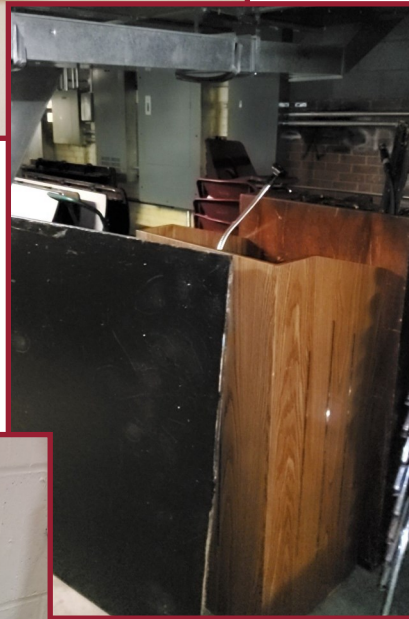
At all three facilities, the PM schedule was missing some of the building's essential assets, such as backflow preventers, fire extinguishers, and emergency lighting.

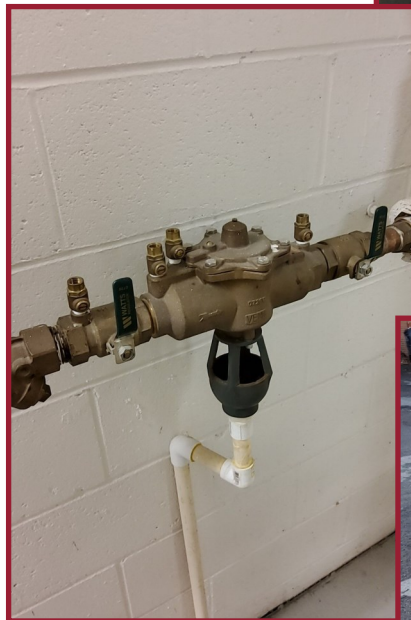
The backflow preventers in two facilities were missing inspection tags to verify that they were in proper working order. Backflow preventer inspections were not identified in the LEA's PM schedule or PM work orders.

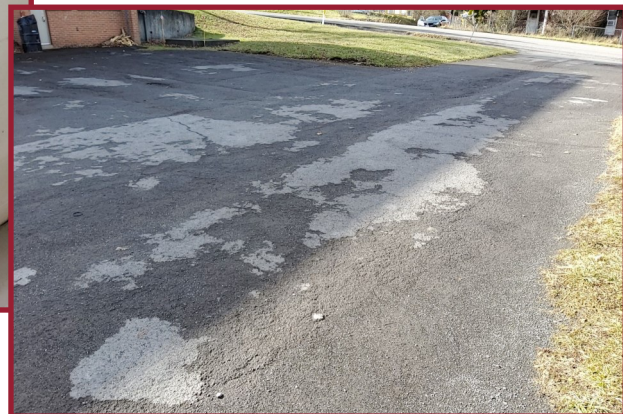
Cracked and deteriorating surfaces were identified in the roadways and parking lots at two of the assessed facilities.

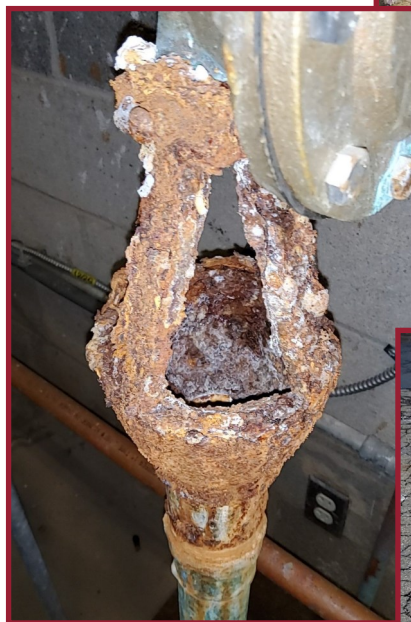
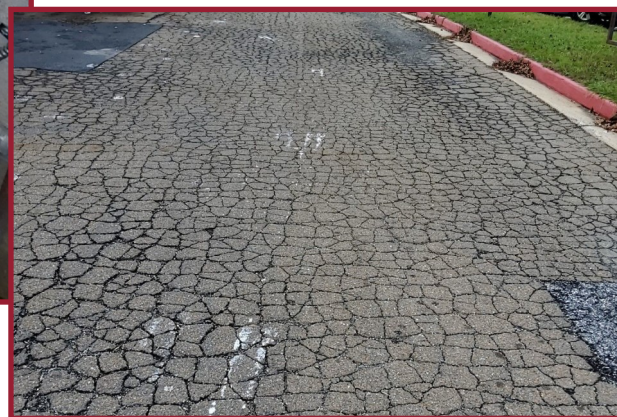
Five facilities were observed with leaking faucets. Backflow preventers were not identified in any facility's PM schedule and the backflow preventers at five facilities were missing inspection tags; one of these facilities was observed with a leaking backflow preventer.

Three facilities were noted with vegetative growth in the walkways. All six facilities had cracks in their parking lots.

- PM activities for roadways, parking lots, and walkways should be added to each facility's PM schedule to help extend the useful life of the existing surfaces, prevent hazardous conditions, and avoid premature capital replacement projects.

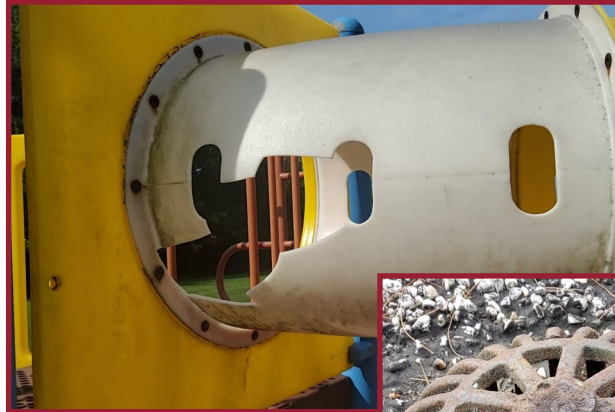
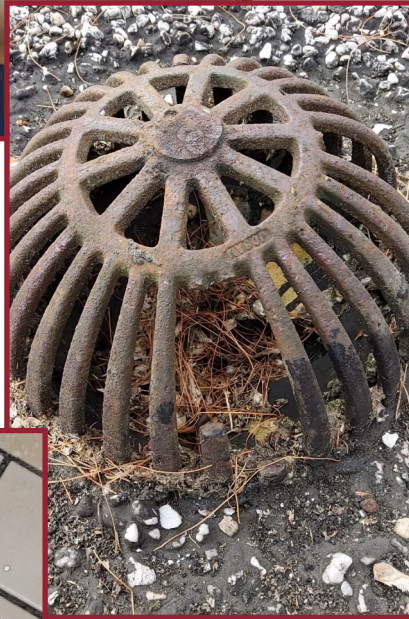
Potential safety issues were observed with these assets at two facilities.

Playgrounds and bleachers were not identified in the PM schedule for any of the assessed facilities.

- Regularly scheduled playground inspections should be created and tracked using the CMMS. Additional training on playground maintenance procedures and requirements may be needed to ensure the required inspections, cleaning, and repairs are taking place.

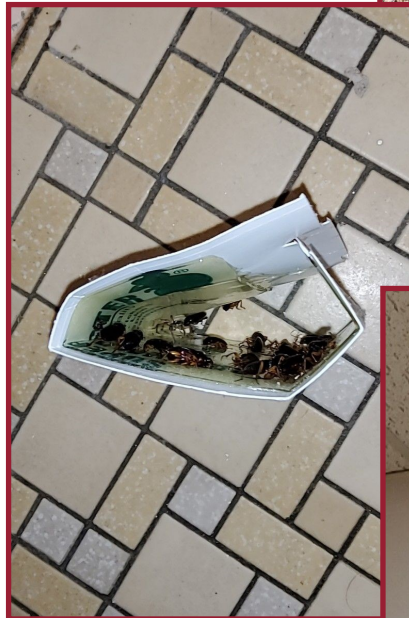
Pest management PM activities were not tracked using the CMMS for any of the assessed facilities. Sticky pest traps did not appear to be dated at any of the facilities to track pest activity and all three facilities were observed with pests in traps.

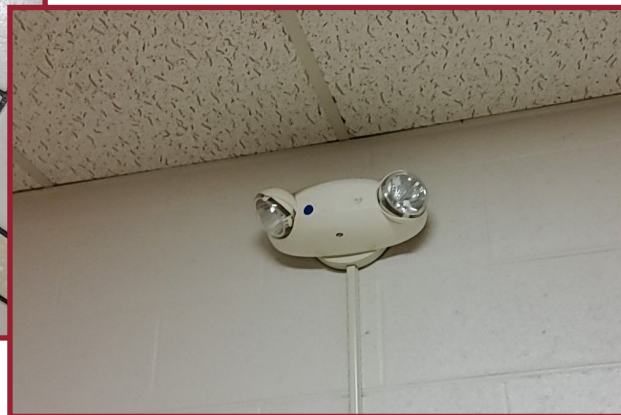
Fire and safety systems were not identified in the PM schedule for any of the assessed facilities. Two facilities were observed with a non-functioning emergency light.

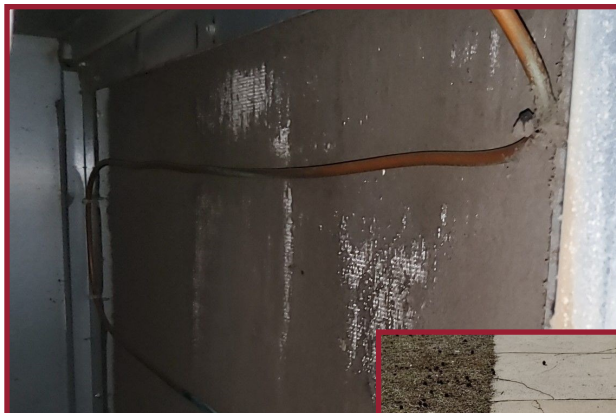
Besides quarterly filter changes, most HVAC equipment was not identified in the PM schedules for the assessed facilities. Dirty HVAC equipment coils were observed at 10 facilities. Eight facilities received a Not Adequate rating in the HVAC category.

- PM activities for roofs, HVAC equipment, and plumbing fixtures and equipment should be added to each facility's PM schedule to help extend the useful life of the existing surfaces and assets, prevent hazardous conditions, and avoid premature capital replacement projects.

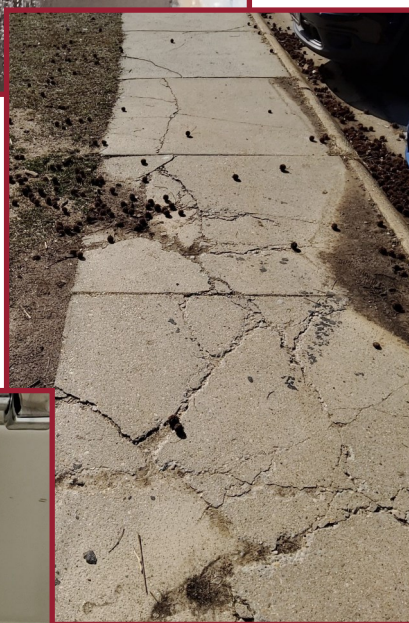
The Preventive Maintenance Tasks document identified monthly condition inspections of the sidewalks, steps, and parking lots, but were not tracked using the CMMS and did not appear in the PM work order history for any of the assessed facilities. Uneven walkway surfaces were noted as potential trip hazards at 11 facilities. The walkways at 18 facilities were observed cracked, damaged, and/or deteriorated.

- Roadways and parking lots should be added to the PM schedule. Consider applying sealants to asphalt parking lots and roadways to slow deterioration until such assets can be resurfaced.

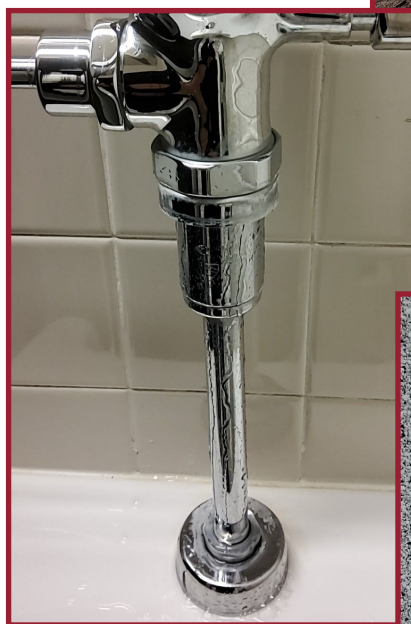
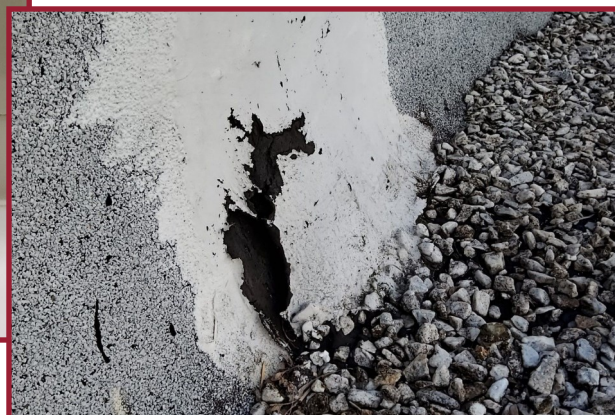
Besides annual backflow preventer inspections, no other plumbing fixtures or equipment were identified in the PM schedules for the assessed facilities or tracked using the CMMS. Leaking plumbing fixtures or equipment were observed at 13 facilities. Five facilities were noted with inoperable sinks, toilets, and/or urinals.

Eight facilities received a Not Adequate rating in the Roofs, Flashing, and Gravel Stops category. Roofing sealants or coatings were noted as cracked and/or deteriorated at 18 facilities.

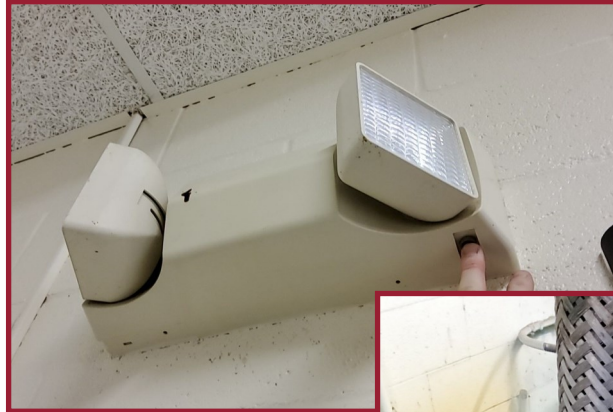
13 facilities received a Not Adequate rating in the Fire and Safety Systems & Utility Controls category. The fire alarm and/or sprinkler system PM work orders were not identified in the CMMS history at nine facilities. Issues were noted concerning emergency lights and/or exit signs at 11 facilities.

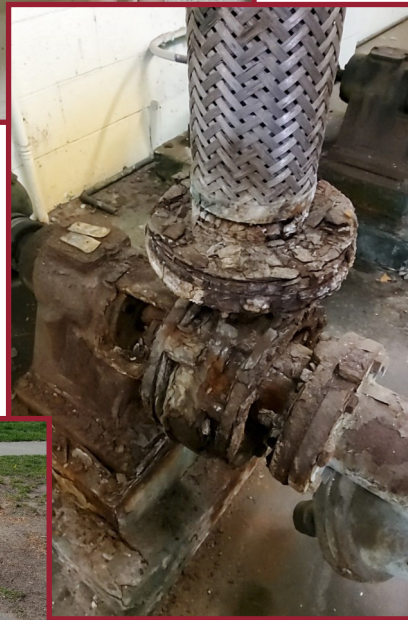
No custodial scope of work, integrated pest management plan, or PM schedule were provided in the required pre-assessment documentation for any facility. The required inspection reports for fire alarms, sprinkler systems, playgrounds, and bleachers were also not provided for many of the assessed facilities. Some essential assets were not identified in the PM work order histories for many of the assessed facilities, such as backflow preventers, HVAC equipment, fire and safety systems, and DLLR-regulated equipment.

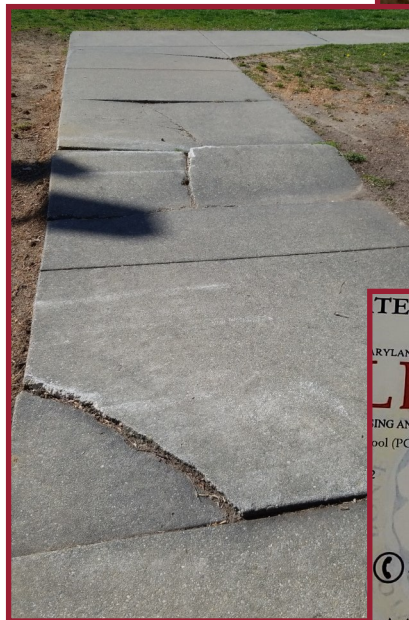
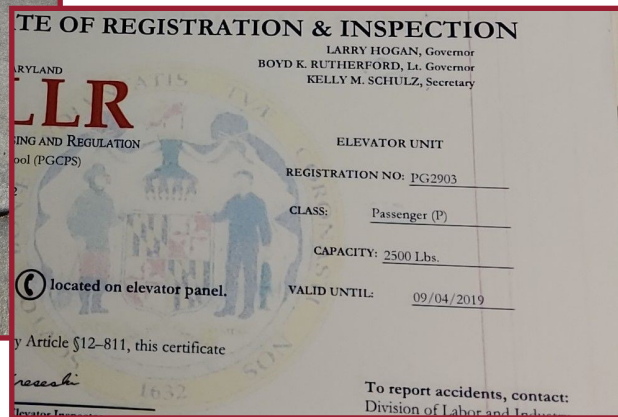
Roadways, parking lots, and walkways were not identified in the PM schedules for the assessed facilities. Trip hazards due to uneven walkway surfaces were identified at 10 facilities. Every assessed facility was observed with cracking walkways and/or parking lots. Potholes were noted in the roadways at three facilities.

- Roadways and parking lots should be added to the PM schedule. Consider applying sealants to asphalt parking lots and roadways to slow deterioration until such assets can be resurfaced. Safety issues should be reported and addressed immediately.

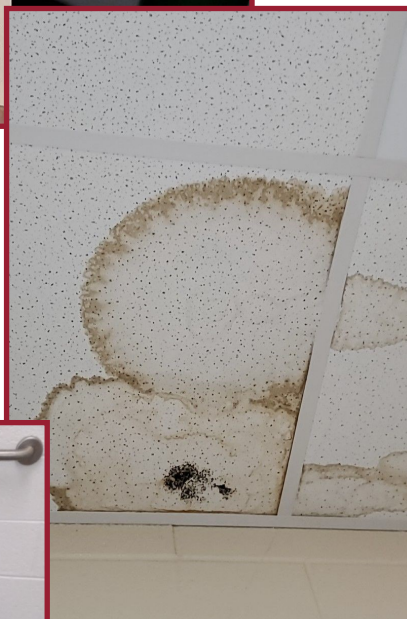
The backflow preventers in two facilities had either missing and/or expired inspection tags to verify that they were in proper working order, and a backflow preventer at the third facility appeared to be leaking. Other than PM work orders for water fountains, no other PM work orders were identified for plumbing fixtures or related equipment.

- PM activities for roofs, HVAC equipment, fire and safety systems, and plumbing fixtures and equipment should be added to each facility's PM schedule to help extend the useful life of the existing surfaces and assets, prevent hazardous conditions, and avoid premature capital replacement projects.

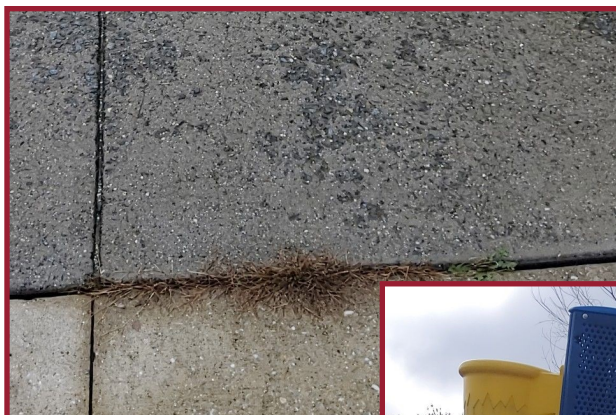
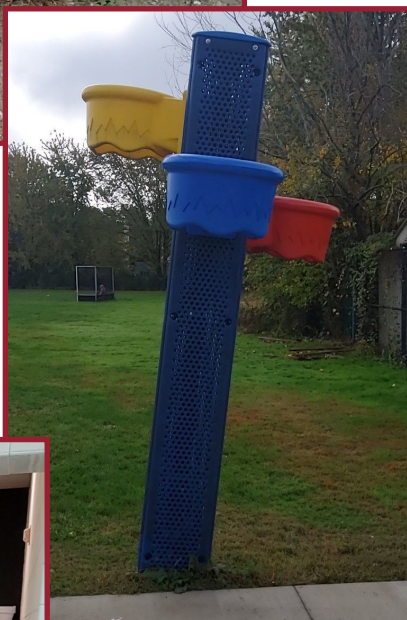
Roadways, parking lots, and walkways were not identified in the PM schedules for the assessed facilities. Cracked and deteriorated concrete walkways were observed at two facilities; both also had vegetation growing from cracks in the walkways and/or roadways.

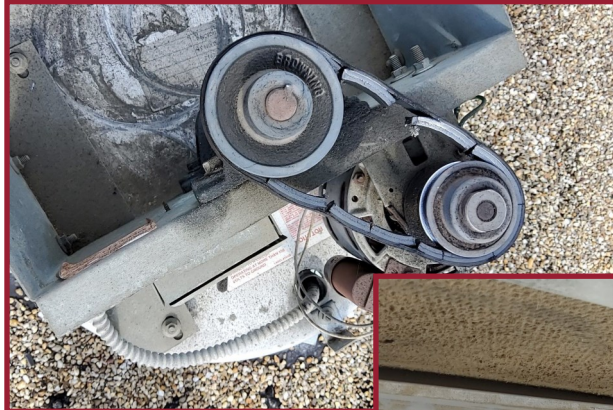
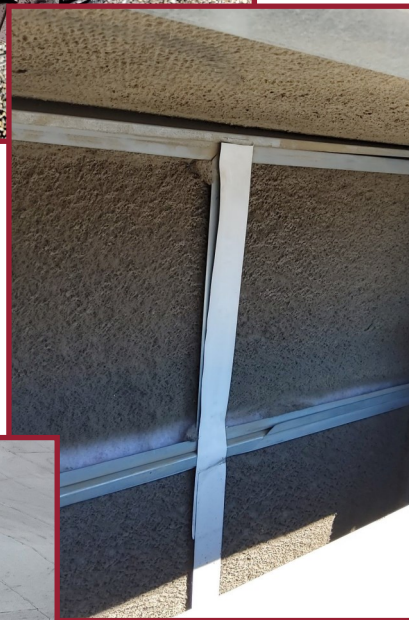
Inoperable exhaust fans were noted at five facilities, and the exhaust fans were observed with cracked belts at five facilities. Dirty filters and/or coils were identified at all six assessed facilities. Five facilities received a Not Adequate rating in the HVAC category.

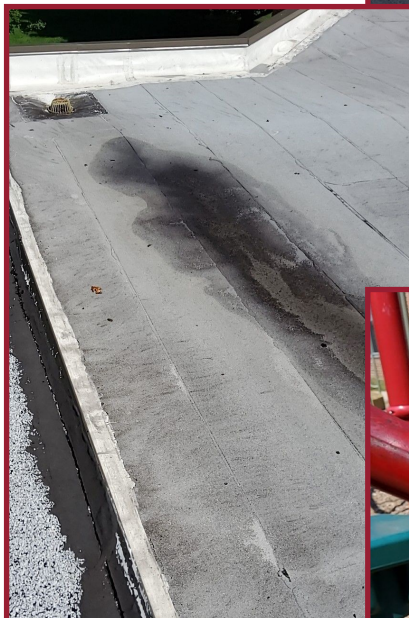
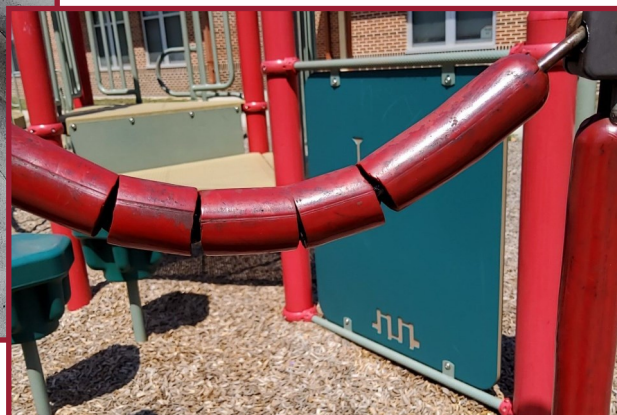
Ponding water or evidence of ponding was observed at five facilities. These same five facilities were also noted with either open seams or cracks in seam sealants. Four facilities received a Not Adequate rating in the Roofs, Flashing, and Gravel Stops category.

Damaged or deteriorated rubberized protective surfaces were observed on the playground equipment at four facilities. Vegetation was growing from cracks in the athletic courts at three facilities.

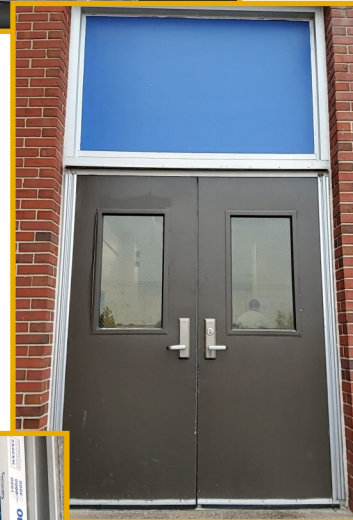
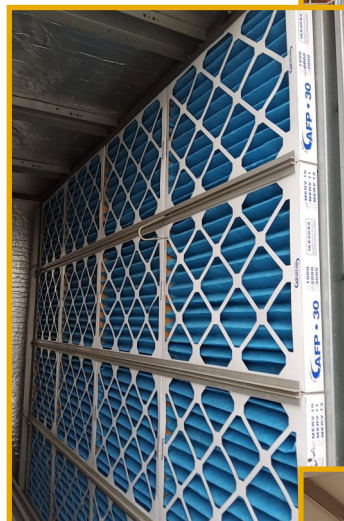
The inspection tags on the backflow preventers were current at all three facilities. Annual backflow preventer inspections were included in the PM schedule at every facility assessed.

Most of the exterior doors appeared to be weatherproof and watertight with little to no signs of deterioration. Annual exterior door inspections were included in the PM schedule at every facility assessed.

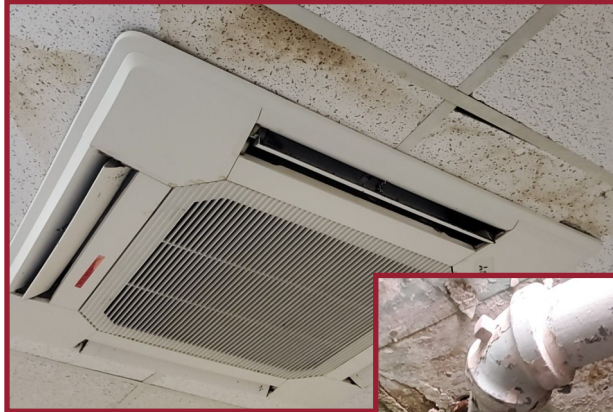
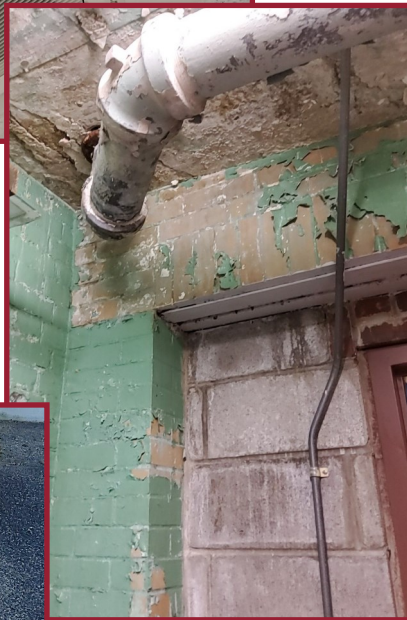
Sagging ceiling tiles were observed at all three facilities, and two facilities were noted with multiple stained ceiling tiles in both classroom and non-classroom areas. Ceilings were not identified in the PM schedules for the assessed facilities.

Damaged walls and peeling paint were noted at all three facilities. Two facilities received a Not Adequate rating in the Interior Doors, Walls, Partitions, & Finishes category.

- Regularly scheduled ceiling inspections should be created and tracked using the CMMS to identify any ceiling tiles missing, stained, or damaged. Corrective work orders should be created in the CMMS immediately following any inspection where deficiencies or issues are noted. Stained ceiling tiles should be replaced once the cause is identified and repaired.

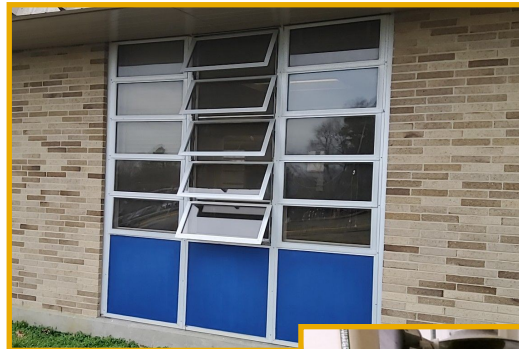
All of the assessed windows operated as expected. The PM schedules at two facilities identified yearly PM for windows. The skylights at the one applicable facility appeared watertight.

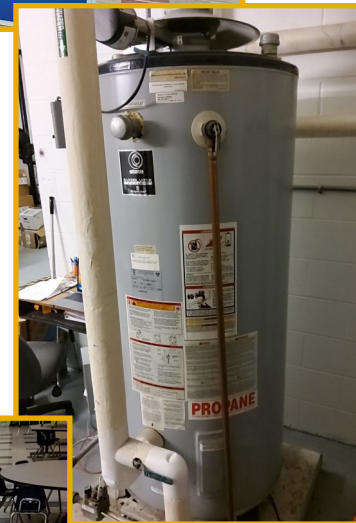
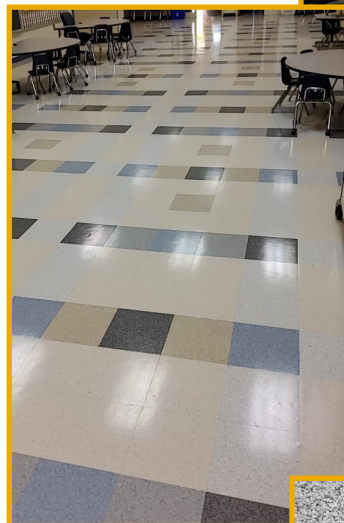
No issues or concerns were identified with the water heaters or hot water distribution at any of the assessed facilities. The DLLR certificates were current and on display for all applicable water heaters.

No issues or concerns were identified with the flooring at one facility, and the other two facilities had no issues noted concerning flooring in classroom areas. Floor cleaning procedures for various surface types are detailed in the Custodial Training and Procedures Manual document.
